ICE INVESTIGATIONS AT
A BEAUFORT SEA CAISSON

1985

K. R. CROASDALE AND ASSOCIATES LTD.

THE NATIONAL RESEARCH COUNCIL
OF CANADA

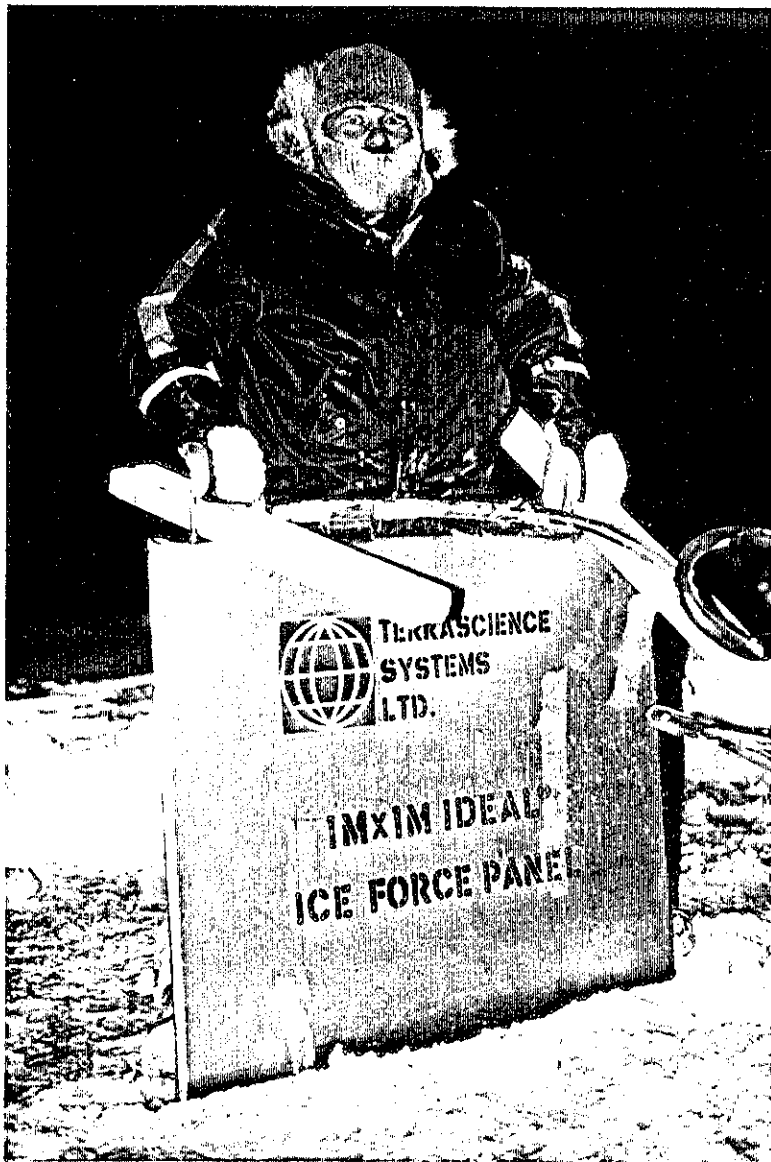
Figure 10

IDEAL 1m X 1m PANEL

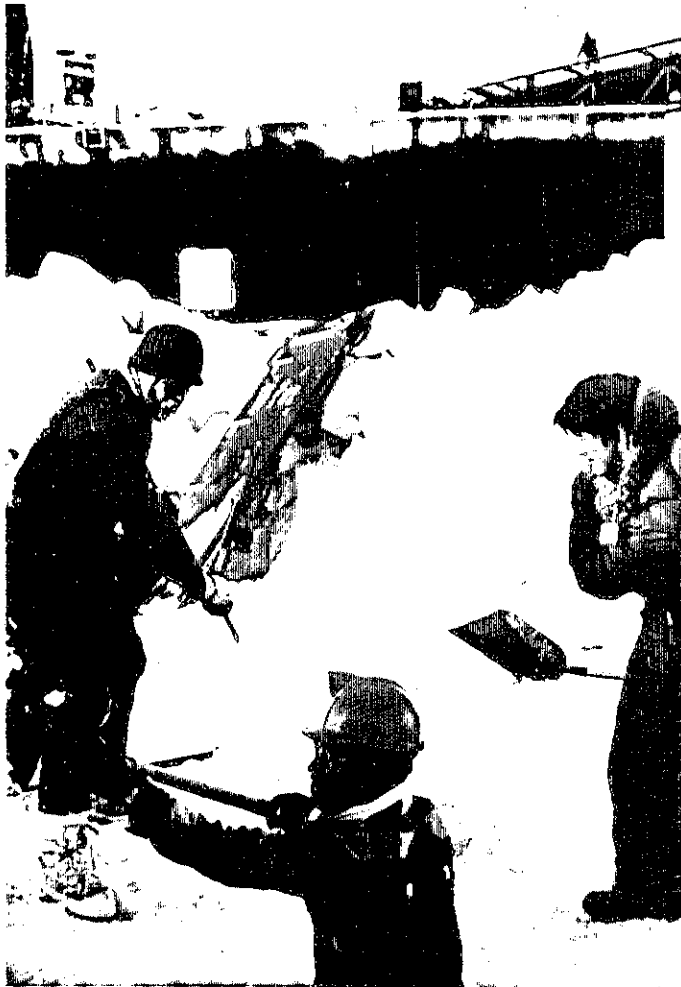
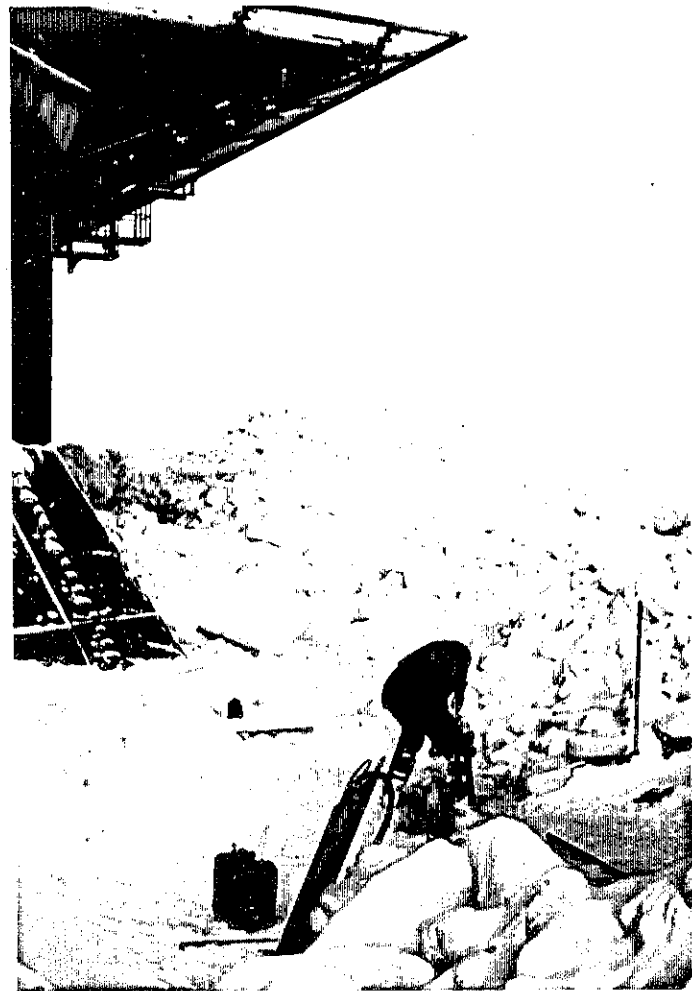
SENSOR INSTALLATION

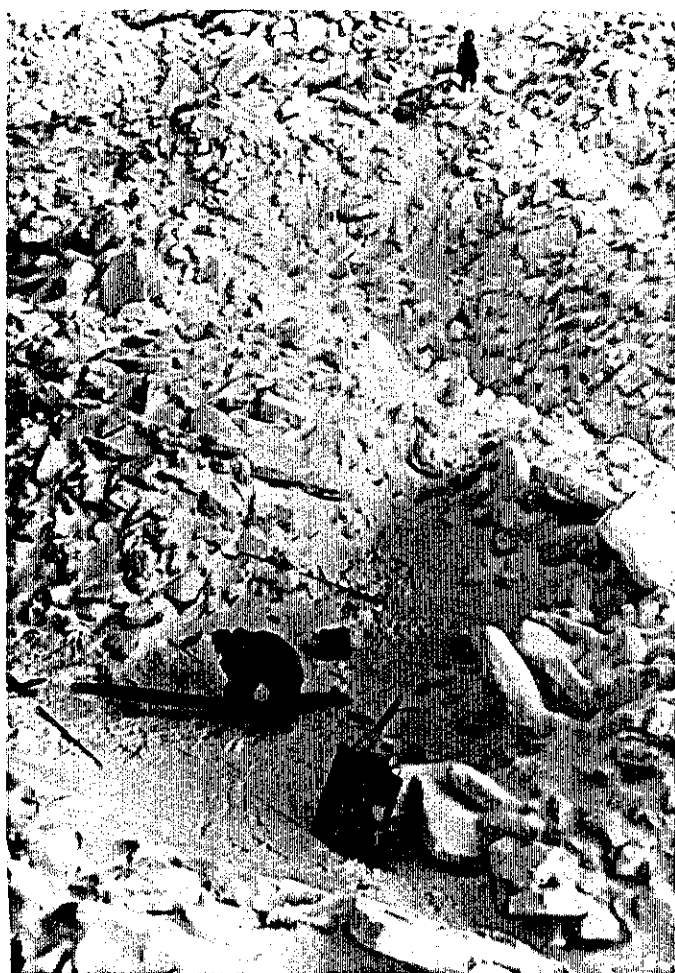
Sensors 2,3&4

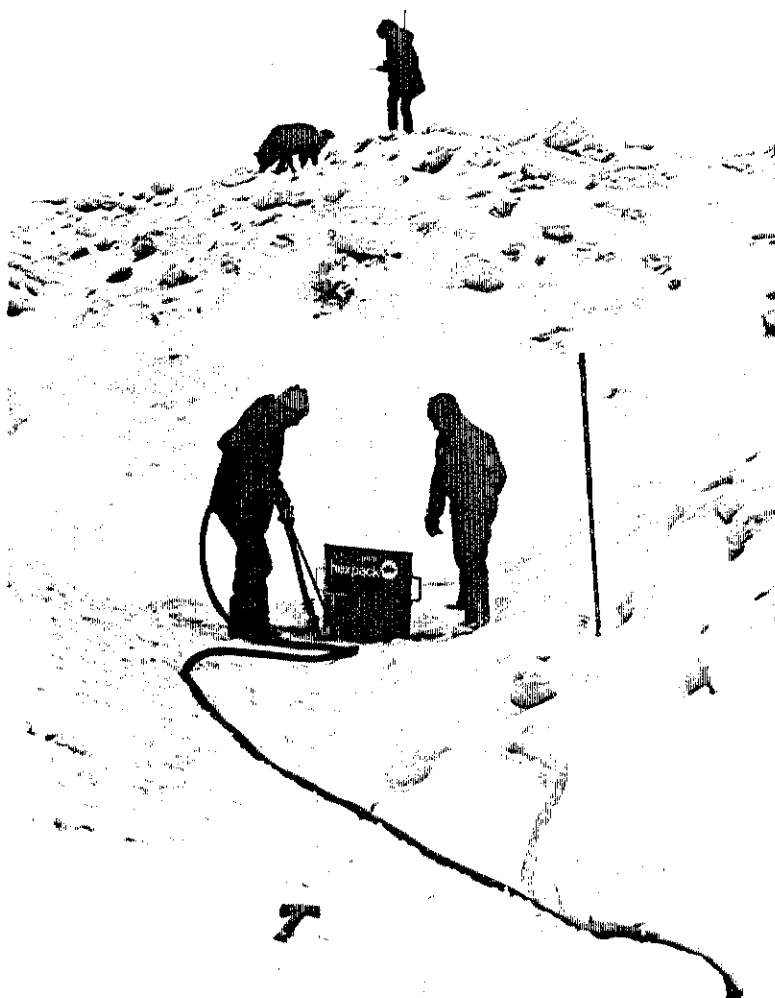
Figure 18

SENSOR REMOVAL USING
STEAM WAND.

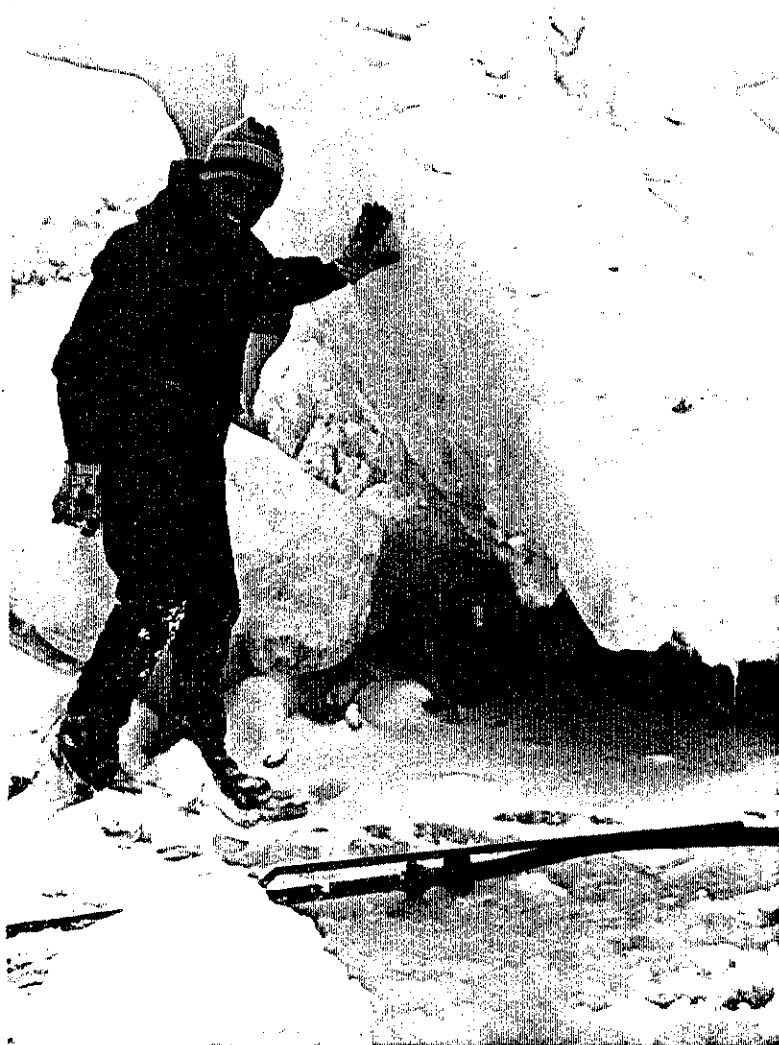
SENSOR 7 (EXXON 103) JUST PRIOR TO
REMOVAL

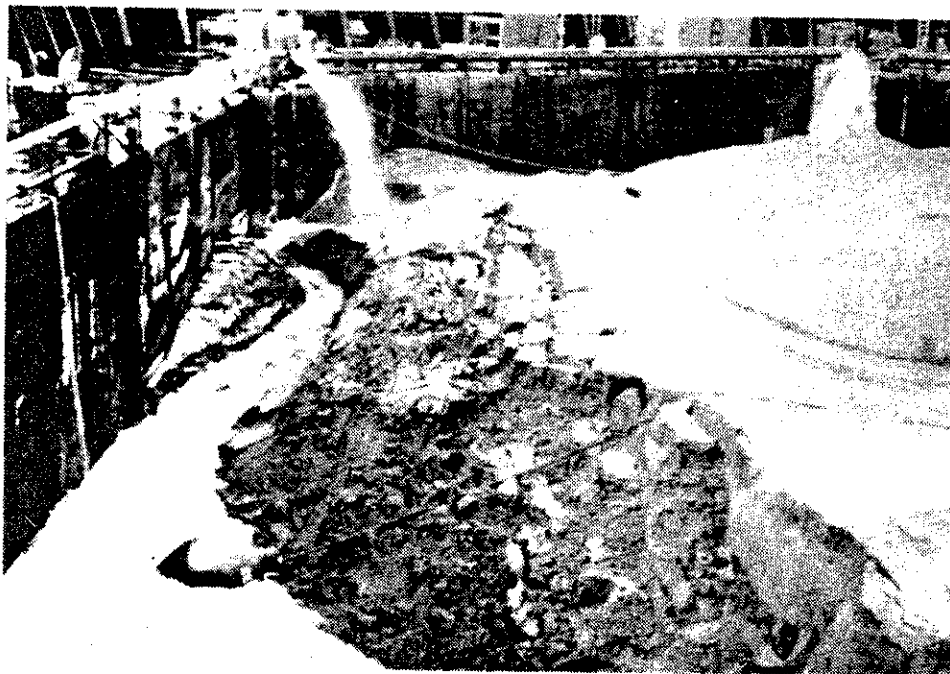
LIFT OFF. **Pumping ballast raised CRI allowing retained fill to flow out under caissons.**

Removal of the steel ring from the sand core had been the subject of speculation all winter. Ballast was pumped from all caissons simultaneously, and was discharged onto the island surface. A shallow depression near the caisson back walls channelled the water to where it would do the most good. After all tanks were uniformly deballasted to a level where the structure was positively buoyant the first sign of movement occurred. Small geotechnical failures occurred at the corner joints, followed by massive piping. As the caisson lifted itself off the berm, the retained fill failed in a classical manner, leaving the central core surrounded by a moat inside the steel walls.
